ROOF SENTRY

Demo High School Report

RE: Demo High School Report

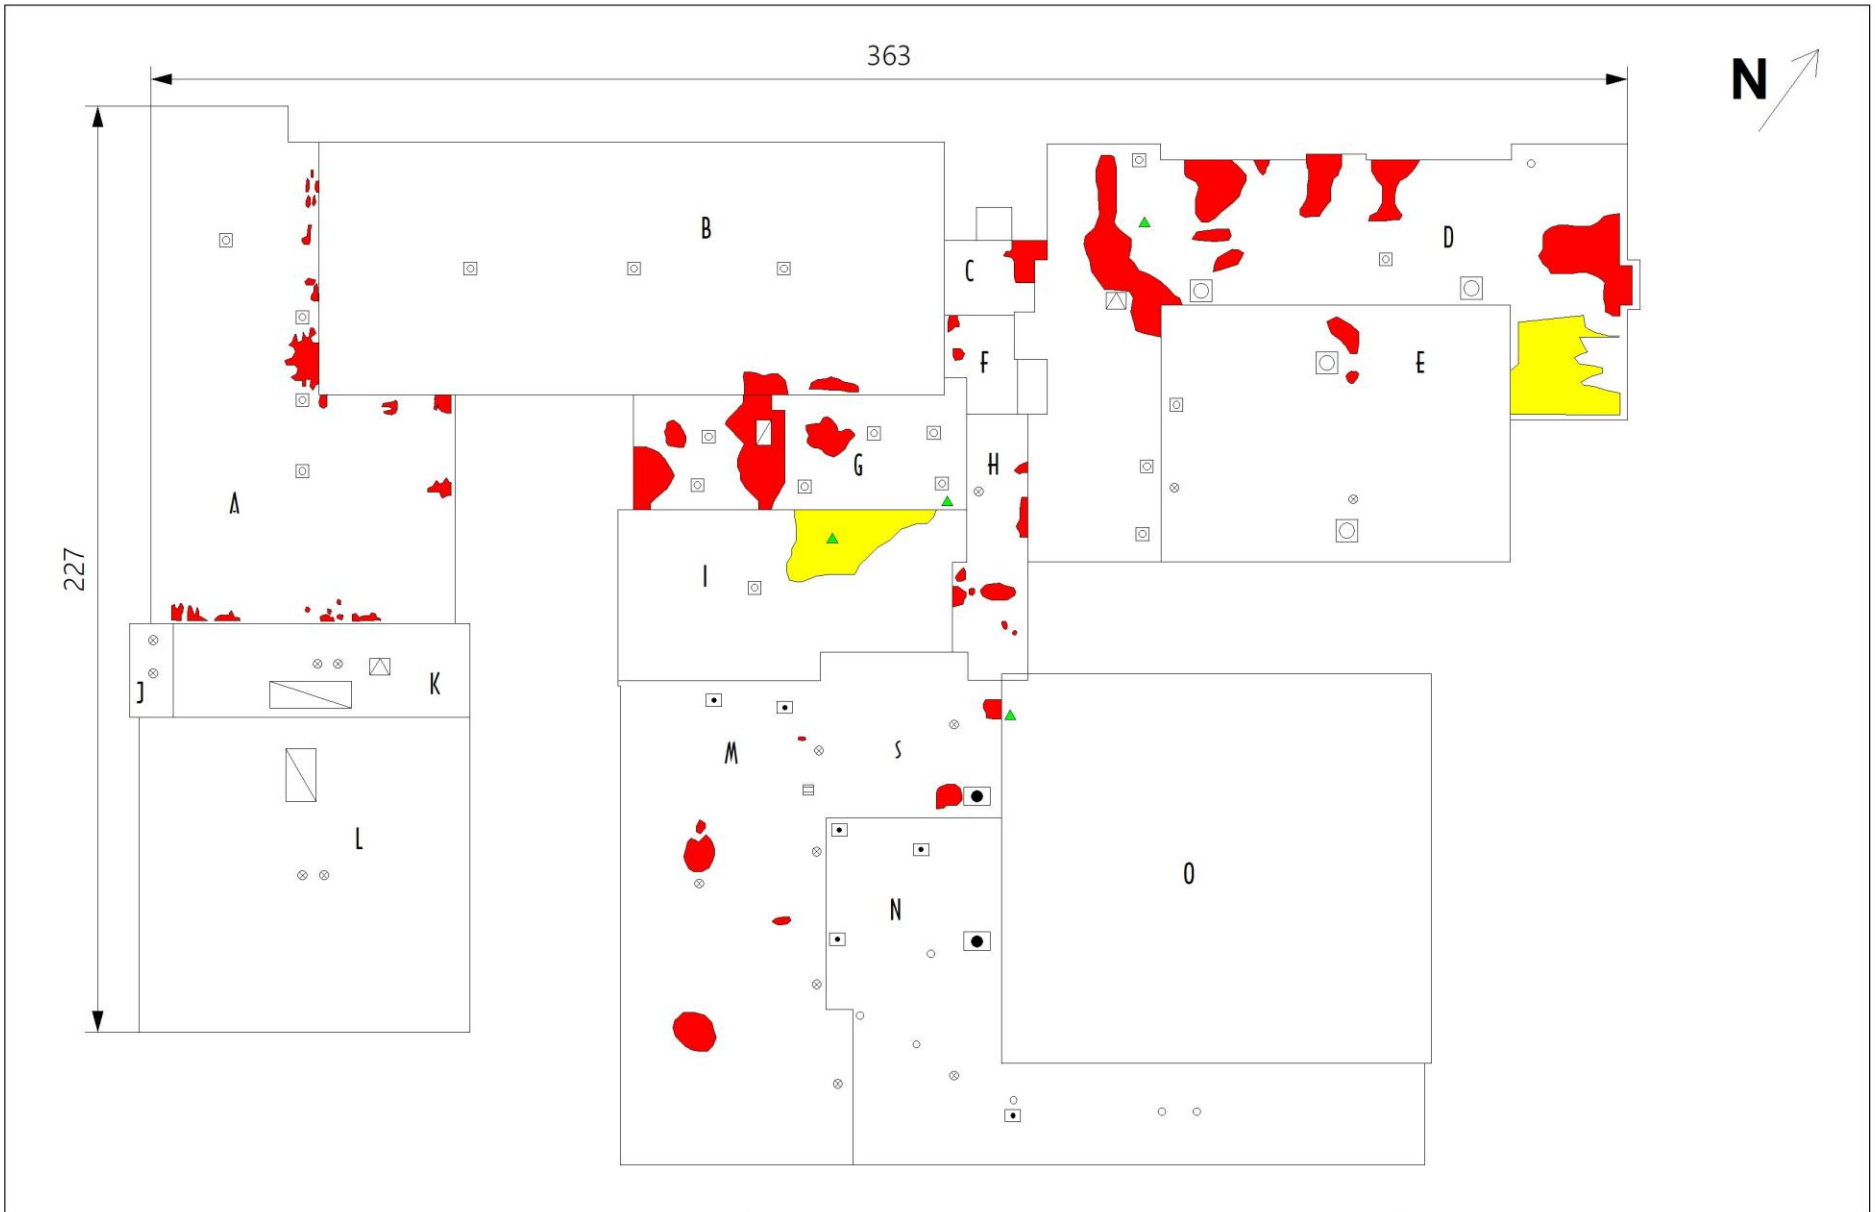
During our series of roof moisture inspections, we were able to detect numerous thermal patterns indicating extensive regions of wet roof insulation. The wet regions of roof insulation found during our inspections were marked on the roof surface with white spray paint and/or shown on the attached CAD drawings. We documented our inspections of the facility by taking aerial infrared photos of the entire roof area. Roof-top photos and thermographs were also taken to show the results of our surveys. The approximate size of the entire facility was 71,278 sq ft. Analysis of the imagery indicates that we found about 2,229 sq ft of wet and 861 sq ft of damp roof insulation, or just over 4% of the entire roof area.
