ROOF SENTRY

Demo High School Report

RE: Demo High School Report

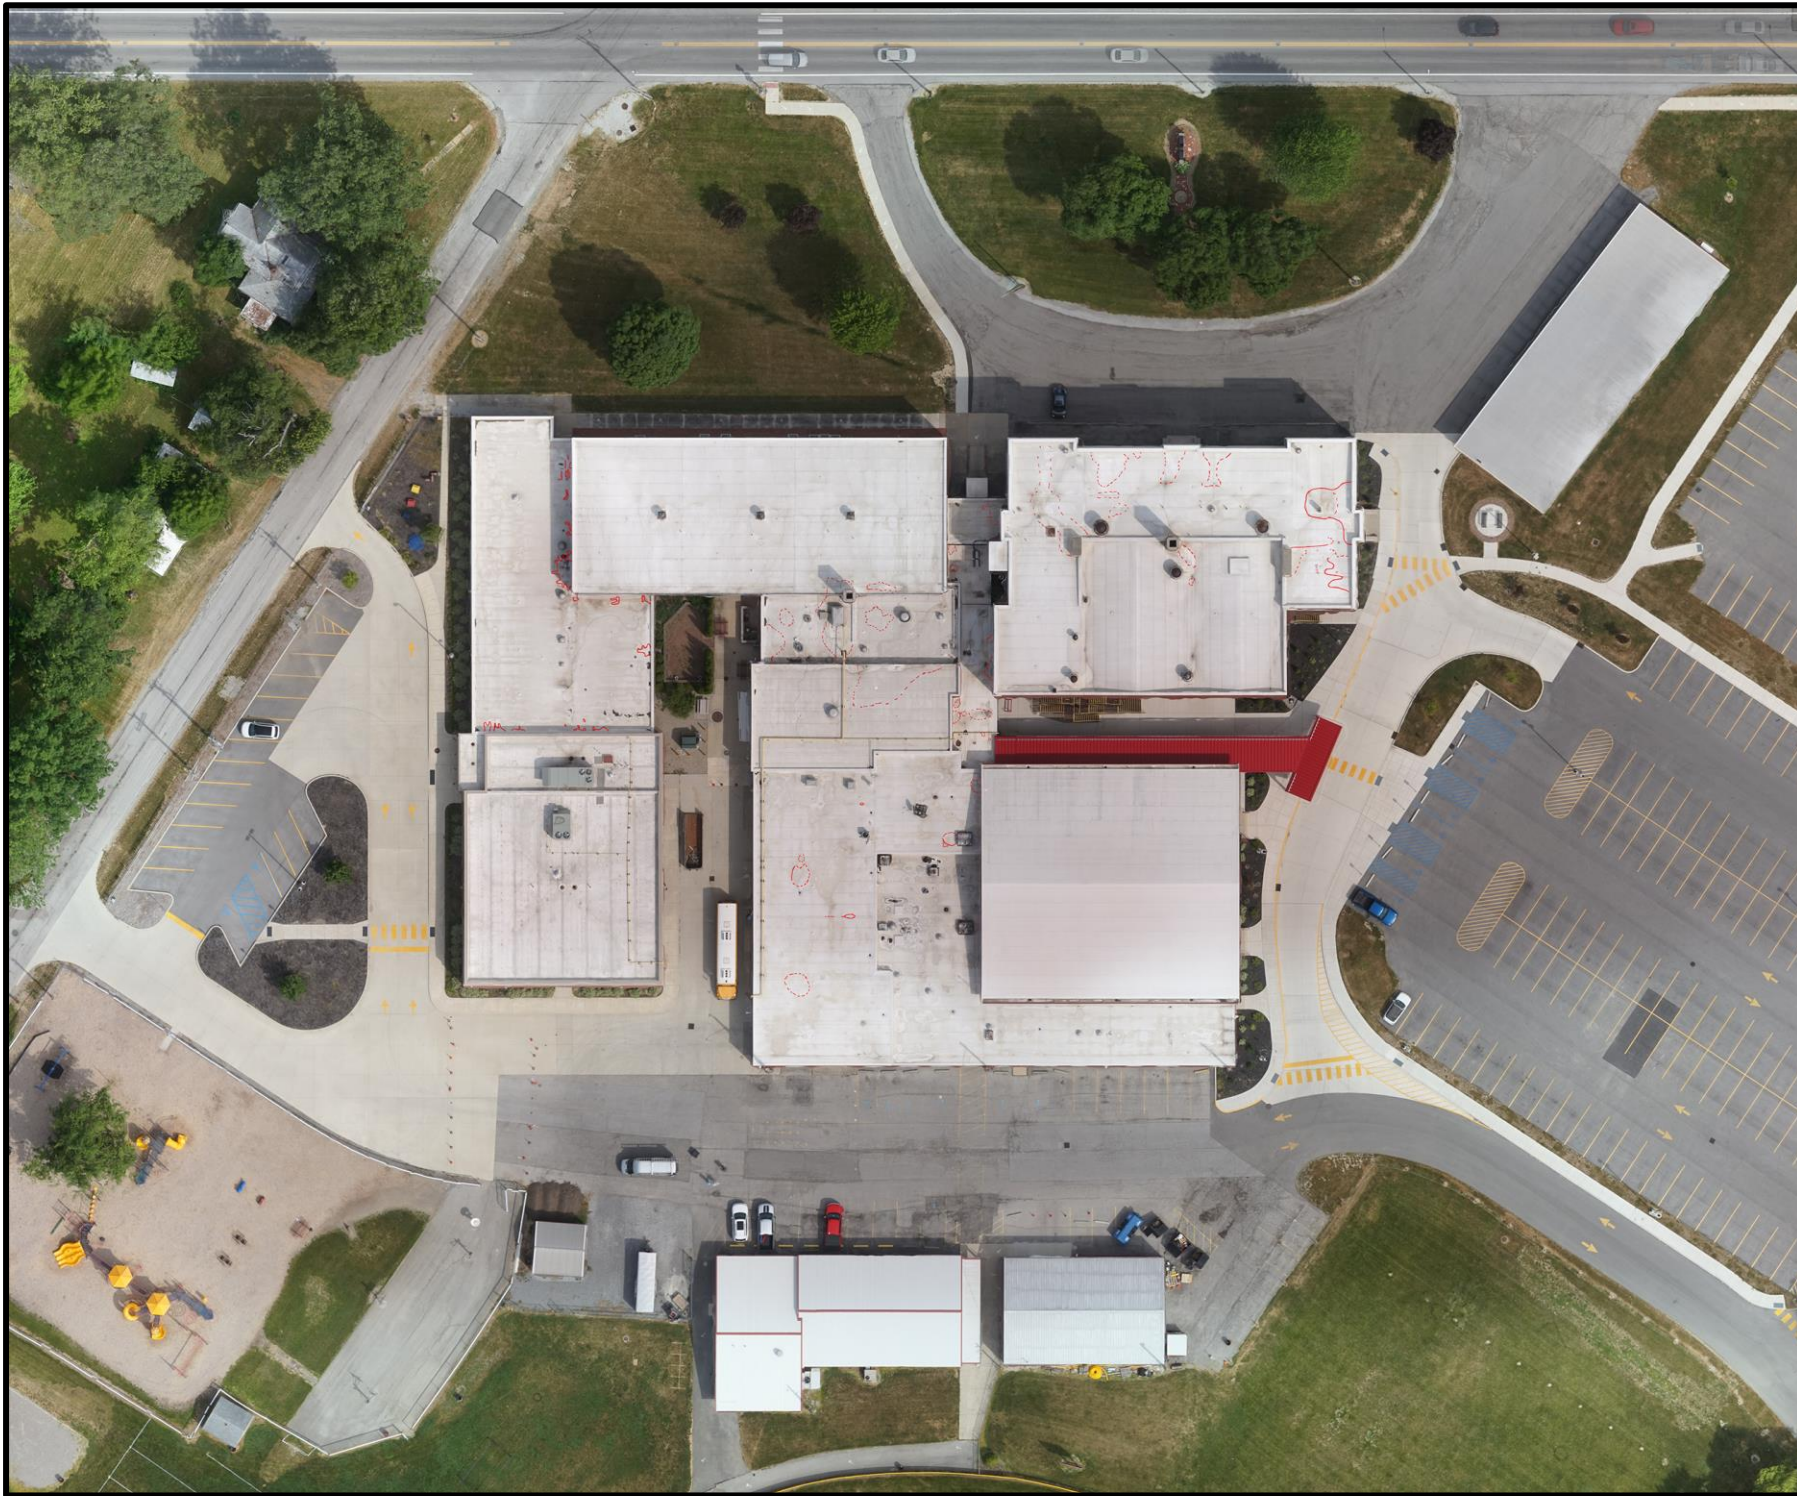
During our series of roof moisture inspections, we were able to detect numerous thermal patterns indicating extensive regions of wet roof insulation. The wet regions of roof insulation found during our inspections were marked on the roof surface with white spray paint and/or shown on the attached CAD drawings. We documented our inspections of the facility by taking aerial infrared photos of the entire roof area. Roof-top photos and thermographs were also taken to show the results of our surveys. The approximate size of the entire facility was 71,278 sq ft. Analysis of the imagery indicates that we found about 2,229 sq ft of wet and 861 sq ft of damp roof insulation, or just over 4% of the entire roof area.

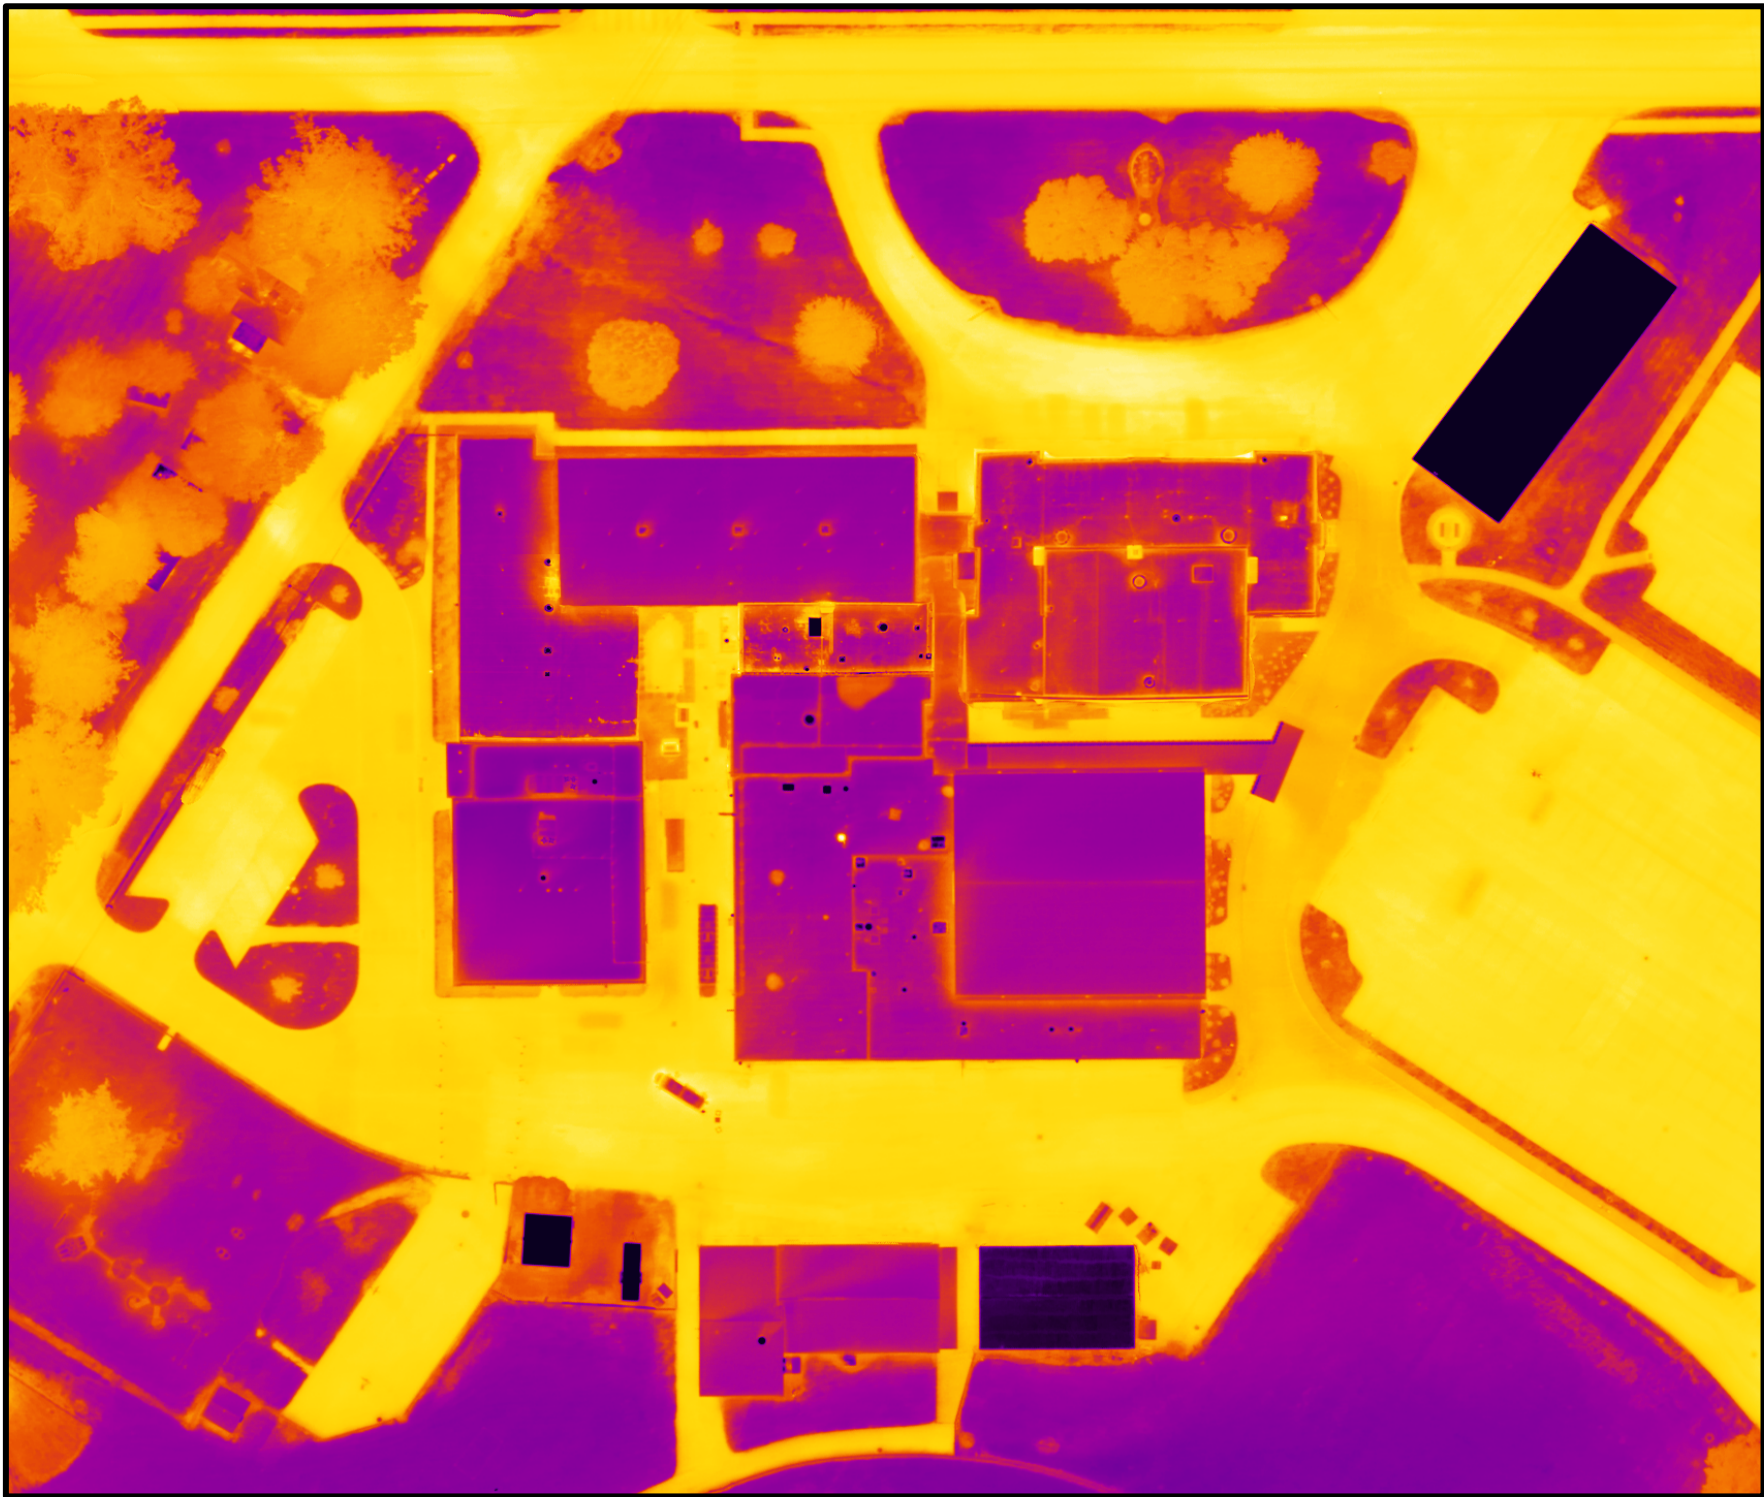
As can be seen on the drawings and aerial photographs, there are a number of small areas of moisture infiltration scattered across the various roof systems. We compiled a list of the separate roof sections listing their physical square footage and showing the amount of wet area for each roof section inspected. In the far right column labeled “Repair Area”, we have included a listing of the approximate area of potential repairs that could be undertaken to fix or remediate the moisture entry in each of the listed school building sections.
